TEST REPORT

Lucideon Reference: 155545 (QT38443/1/DT)/Ref. 1/Supp1

Project Title: Accelerated Weathering Tested to ETAG 034 and TS EN 772-22 on a

Jesmonite GRC Grade 18. Metallic Panel

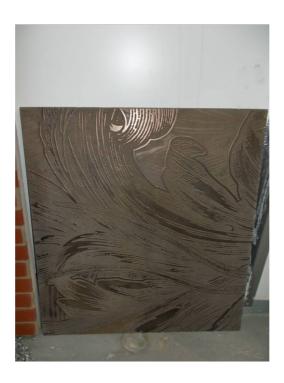
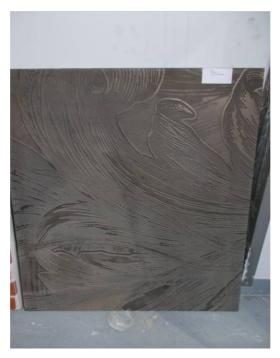
Visual inspection concludes that there was no damage to the Jesmonite GRC Grade 18. Metallic panel tested.

Plate 1 - Before and After Weathering of the Jesmonite GRC Grade 18. Metallic PanelNote variation in colour due to lighting conditions. No visual damage.
